**Summary of EPA Surface Water Sampling of Select Metals  
Results to Date  
Gold King Mine Blowout**

August 7, 2015

## Attachment 2: Trends

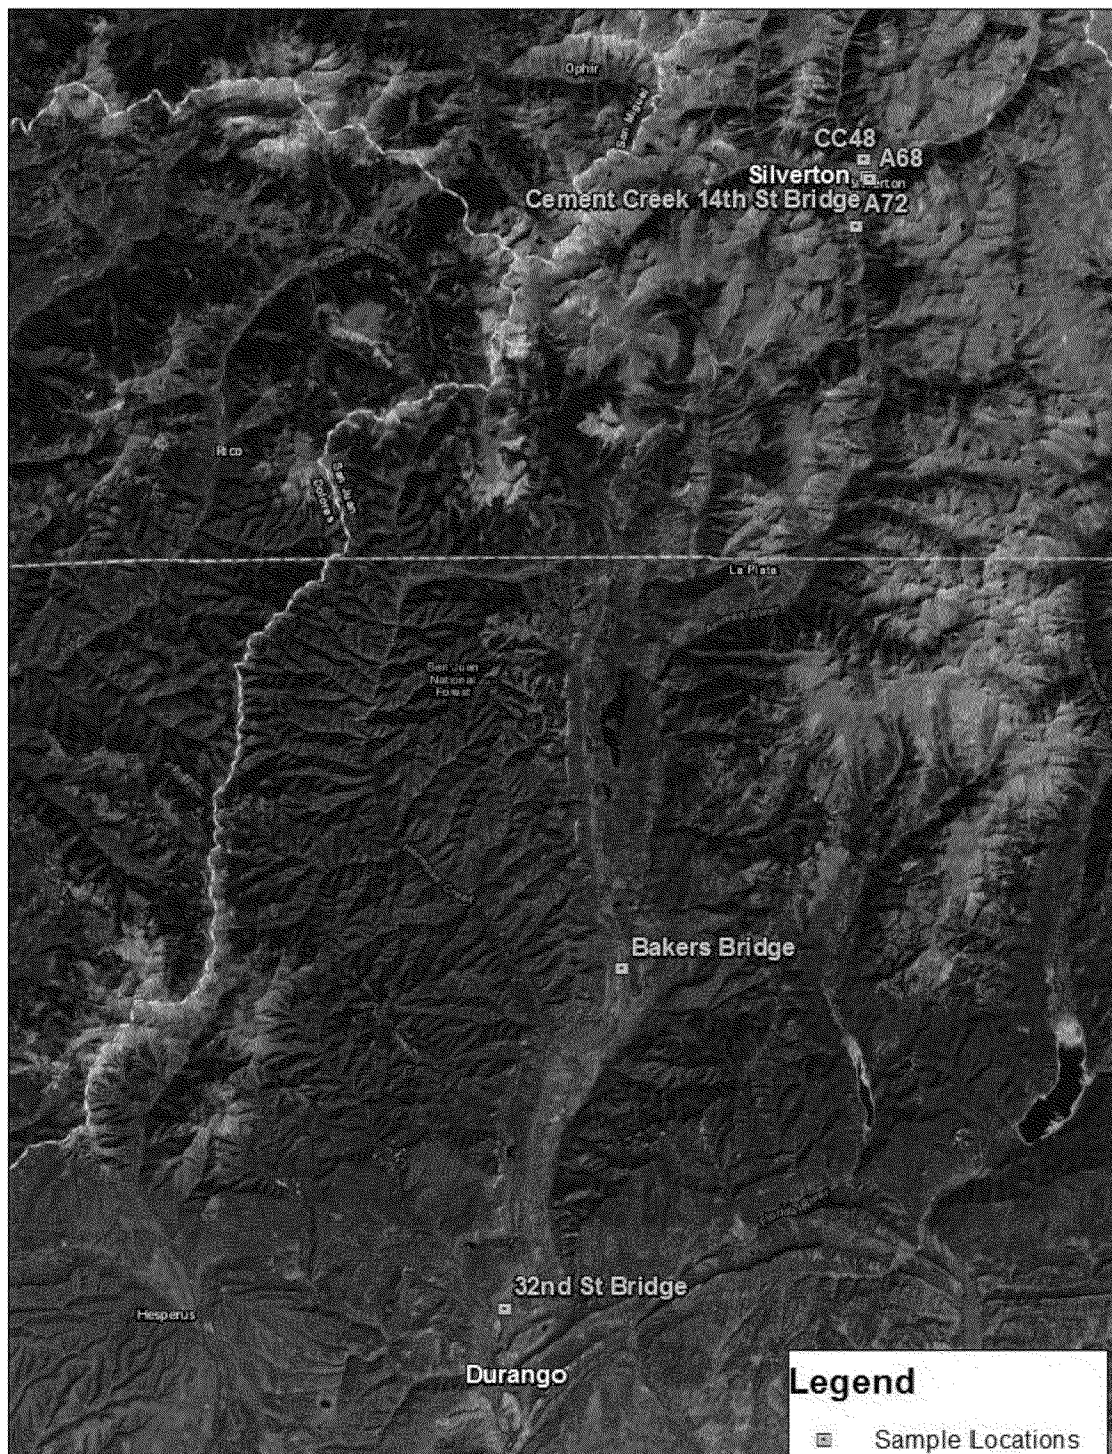
## Attachment 1: EPA Sampling Locations

EPA initiated a sampling effort on August 5, 2015, to assess the impacts of the blowout at the Gold King Mine near Silverton, CO. Surface water quality samples were collected from 7 locations (see Attachment 1). Two of these locations were on Cement Creek and 5 of these were on the Animas River in Colorado. These locations were selected based on the fact that an historical dataset already exists at these locations and they will serve thus as good indicators of conditions before, during and after the event. Data depicted are the results of samples collected over two days. These samples were delivered to the lab on August 6<sup>th</sup>. Results were available and evaluated on August 7<sup>th</sup>.

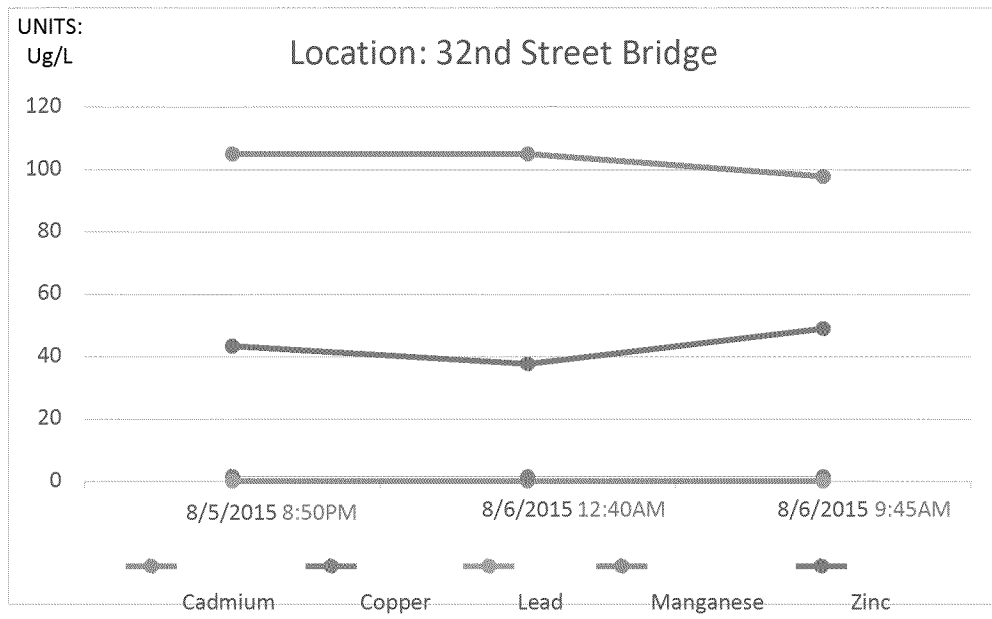
The fifth graph is of the 32<sup>nd</sup> Street Bridge sampling location. At the time the samples were collected, it does not appear that the contamination had yet reached this sampling location.
